backdraft

The newsletter of Fire Protection Engineering / Code Consulting

Fall 2002

Due Diligence

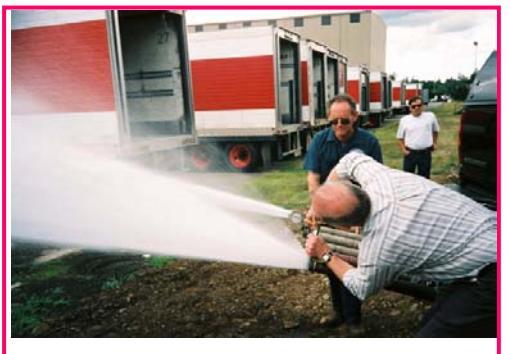
Insurance company engineer conducting pump test

After completion of the construction, and during the testing of the fire pump, it was determined that the jockey pump (10 GPM) would not shutoff and the system pressure could not be maintained. It was determined that another operation on the site was using between 20 GPM and 500 GPM from the system on a continuous basis. The client and ESH both agree that we learned a valuable lesson. If at all possible do not connect the fire pump to the distribution main on the site. It should be connected directly to the sprinkler systems even if new underground mains are needed. See the Applications section of **BACKDRAFT** for a discussion on how the problem was solved.

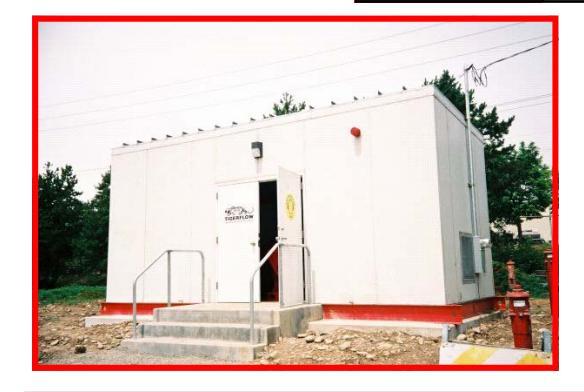
ESH Consultants specified pre-fabricated pump house with diesel driven fire pump, controller and jockey pump.
